715 Bayland Avenue Woodland Heights

CERTIFICATE OF APPROPRIATENESS

Proposal: Alteration – Porch

December 16, 2015 HPO File No. 151214 715 Bayland Avenue Woodland Heights

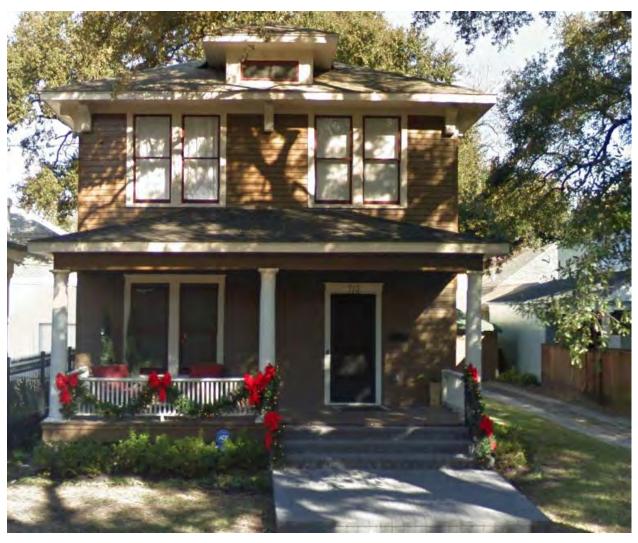
CURRENT PHOTO

The applicant recently installed garden pavers over the existing concrete steps, an inappropriate alteration, without a COA.

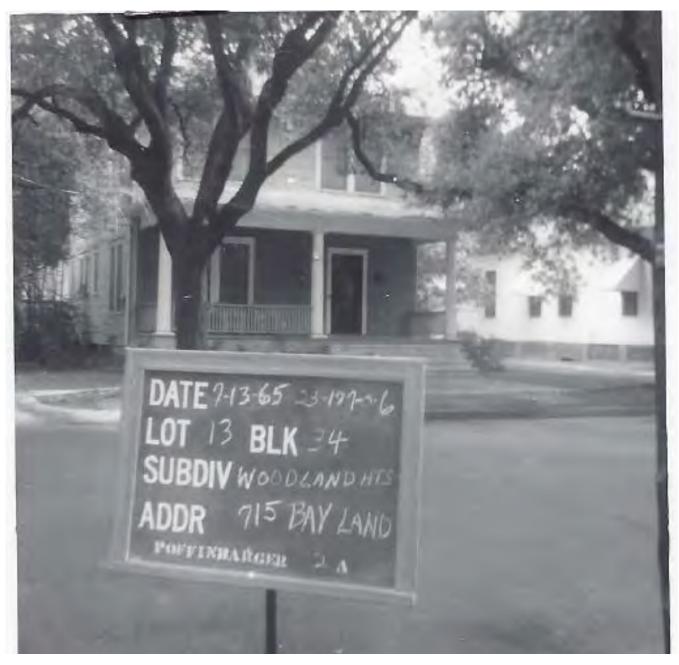
PHOTO FROM HARRIS COUNTY ARCHIVES CIRCA 1965

The concrete steps are likely not original.
	(10)	The proposed alteration or addition must be compatible with the massing, size, scale, material and character of the property and the context area; and The addition of brick steps, brick wing walls, and brick pedestals is not compatible with the existing character of the property or with the materials or character found in the area. There is one contributing structure within the immediate context area that has brick steps but they are likely not original.
	(11)	The distance from the property line to the front and side walls, porches, and exterior features of any proposed addition or alteration must be compatible with the distance to the property line of similar elements of existing contributing structures in the context area.

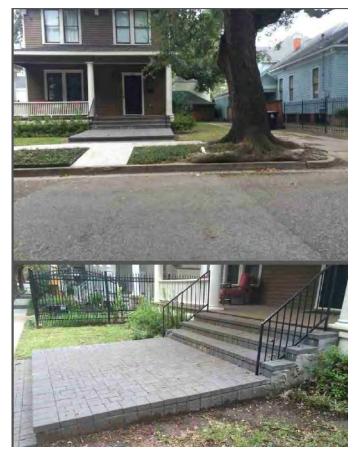
EXISTING

Front Elevation: The existing residence contains one large step leading to three more risers that span from column
